COMPLIANCE

ENGINEERING ASSESSMENT OF A POSSIBLE NON-COMPLIANT GLAZING INSTALLATION

Glass Technical Manager,
Australian Glass & Window Association

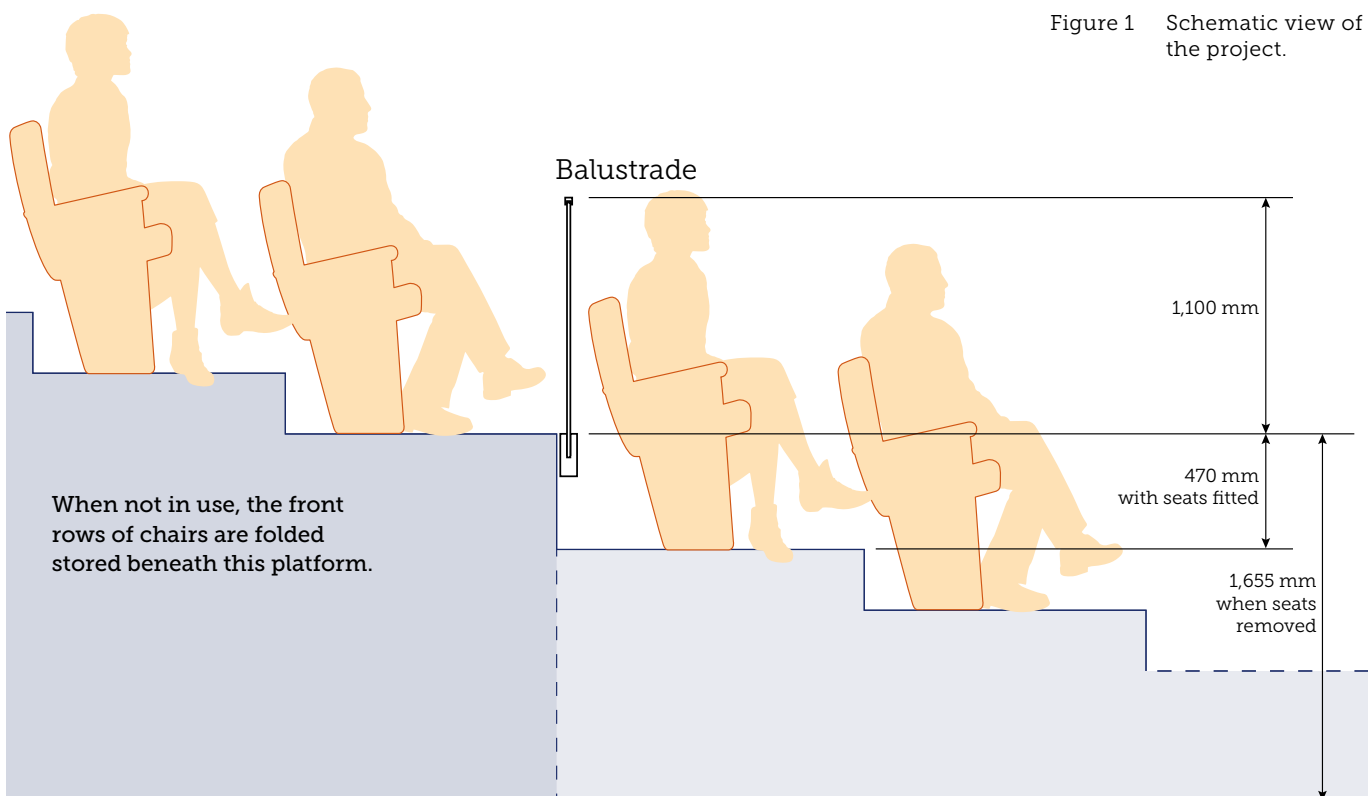
Figure 1 illustrates some the core elements of the project under review.

In reviewing the information provided, we learned that 12 mm thick toughened glass was used in the balustrade, which was based on the applied live load (imposed load) of C3 (0.75 kN/m). However, it should have been C5 (3.0 kN/m) as required in Table 3.3 of AS 1170.1. C3, applies to areas such as stairs, landings, external balconies, and edges of roofs, while C5 applies to places such as theatres, cinemas, grandstands, auditoriums and shopping malls.

- The largest of the glass balustrade's overall dimension was 1,555 mm in width and 1,200 mm high with a thickness of 12 mm.
- The handrail, which is located on top of the glass, was not part of the original design and poorly connected to the glass and adjacent wall. We considered this to be a top rail or non-load supporting handrail.
- The top rail is entirely removable in order to provide access down to the auditorium floor from the upper seating.
- The top rail was not properly connected back to the main structure.

From our assessment, a compliant system would be required to have a glass thickness of approximately 25 mm, which is greater than the actual glass thickness used in this project. As previously mentioned, the whole system was therefore considered non-compliant.

Ultimately, the system as designed uses a thickness of 12 mm. Our findings indicate that a compliant system requires a thickness of 25 mm.
