WINDOW FALLING OFF A HIGH-RISE BUILDING

Dr Pouya Abtahi

Glass Technical Manager

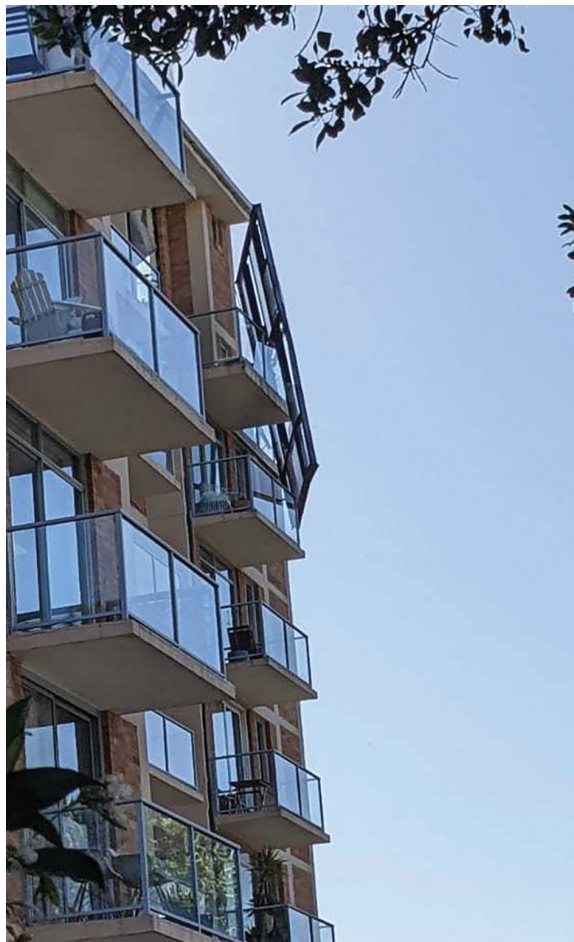
The image of a large window caught as it fell, suspended precariously on an eighth-floor apartment balcony, was beamed into living rooms on the News last October. While not as devastating as the fire at the Lacrosse Building in Melbourne or the structural fiascos of the Opal and Mascot Towers in Sydney, it again highlighted the need for all the components of a building to meet Australian Standards, the National Construction Code and, importantly, to be correctly installed.

The day the window fell, Sydney experienced high winds of 90 km/h. These strong winds were a factor in the incident. NSW Fire and Rescue used their ladder truck to move the 500 kg window, so it was less likely to fall any further and hurt anyone below. The glass in the window had also broken and fallen but luckily no one had been below.

the cause, engaged an engineer to conduct a forensic investigation to determine the contributing factors. The Strata Manger shared the Engineer's Report with AGWA. It indicated that insufficient fixings had been used in securing the window frame and that, together with the excessive wind load on the day, had caused the window to fall.

In addition, the wind direction and elevation of the apartment, meant that the failed window was being subjected to an external negative wind load. This was exacerbated by an open window on the other side of the apartment, which created an internal positive wind load on the window. These two pressures together created excessive forces on the window which, combined with the inadequate fixings, led to it being dislodged.

To make the building safe, AGWA believes the fixings and the windows needed to be checked for structural integrity. Wind pressures can play havoc with windows that have not been adequately secured using the required number and method of fixing them in place.

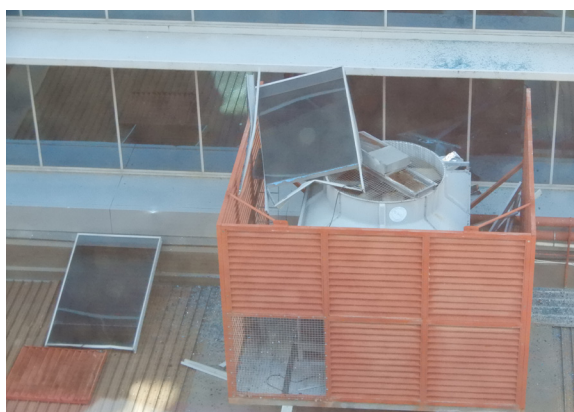
This incident is not the only one of its kind. The lower picture illustrates a second example of window structural failure in recent months and the potential risk to the community that issues like this can pose. Window suppliers must ensure they meet the wind load requirements requested by the customer, while the installer needs to ensure that the number of fixings is in line with the manufacturer's instructions or use the AGWA Window and Door Fixing Guide for the required minimum number of fixings.
